Property Inspection Report

**29 Maple Ct,
Yandina, QLD,**

**Inspection Prepared for:
BMP Property Management**

Date of Inspection: 21/3/2026 | Time: 10:00 AM

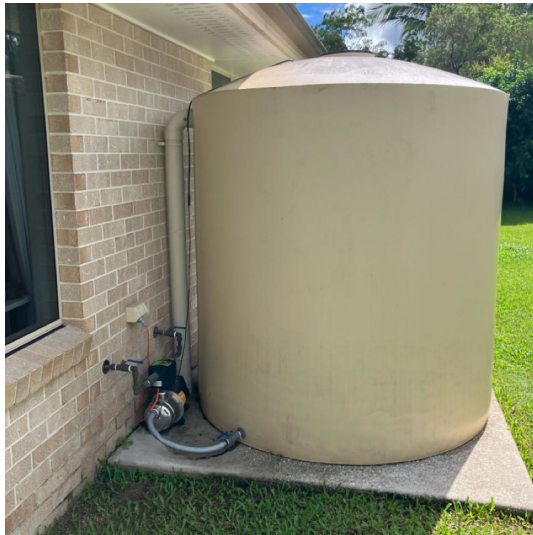
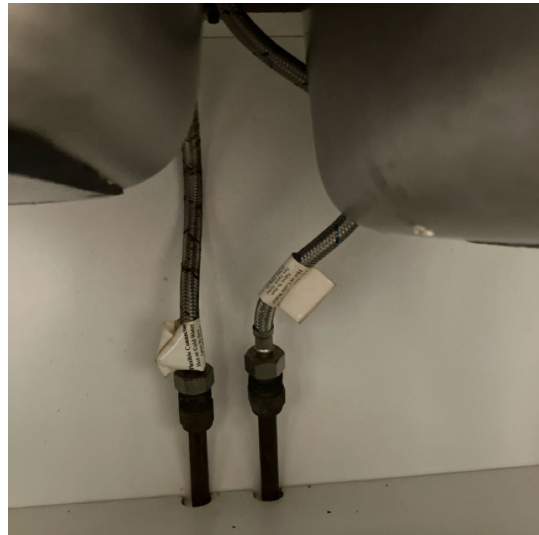
- A water pump and water tank storage were located at the east side of the property. The function of the water pump and associated systems have not been tested as part of the inspection process and should be checked at the final settlement inspection.
- We recommend all braided flexible water hoses in the property be checked regularly and replaced as required to prevent water damage.

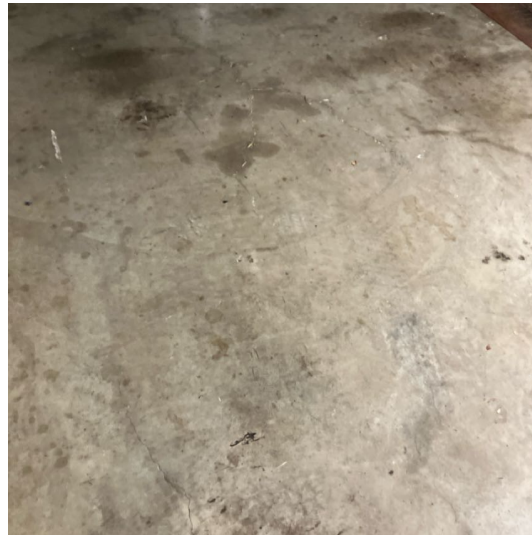
- Most areas of the concrete slab not visible due to floor coverings.
- All concrete floor slabs experience some degree of cracking due to shrinkage in the drying process. In most instances floor coverings prevent recognition of cracks or settlement in all but the most severe cases. Where carpeting and other floor coverings are installed, the materials and condition of the flooring underneath cannot be determined.

- Visible sections of the concrete slab appeared satisfactory.

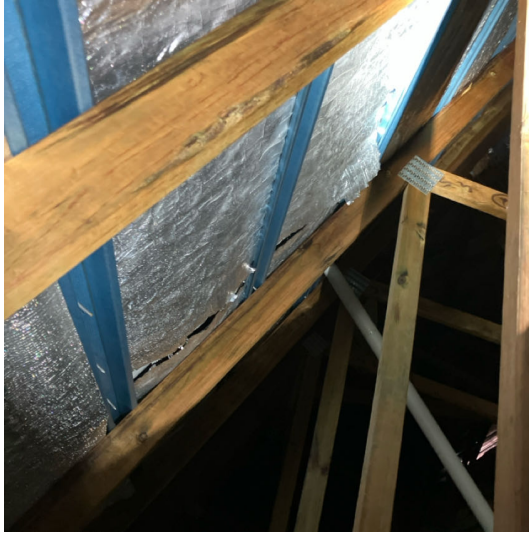
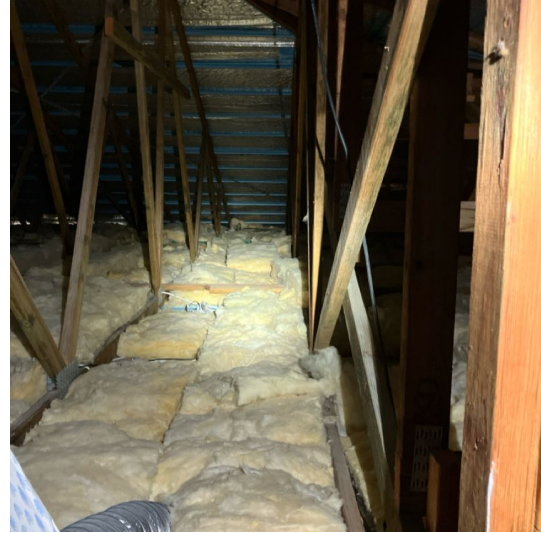
- Insulation averages about 125mm to 150mm in depth.
- Insulation appears adequate.
- The sarking material appears in good condition.

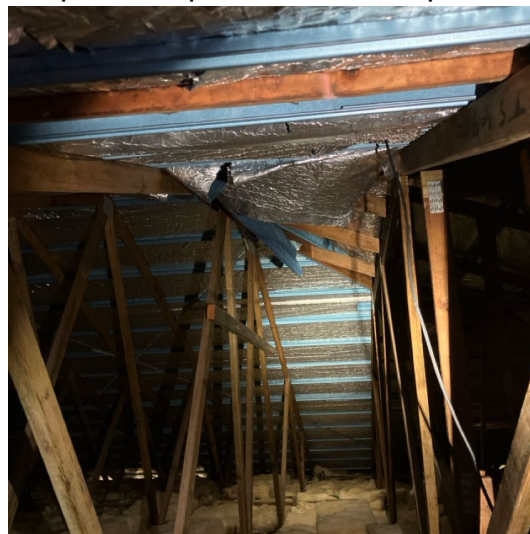
3. Insulation Issues

- The sarking (optional material under roof covering to provide additional protection against water ingress) is perished/torn in areas. Recommend review for repair or replacement as required.

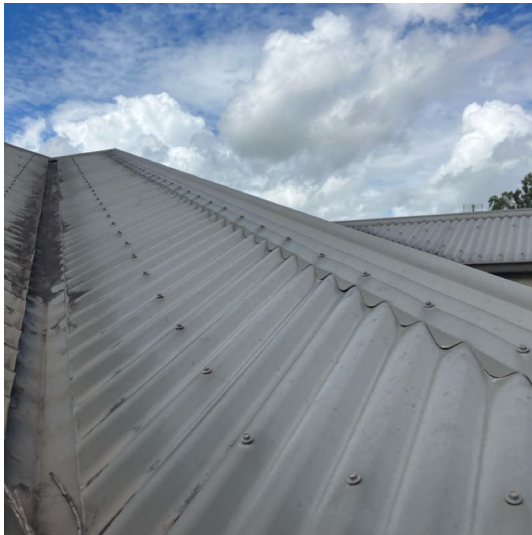
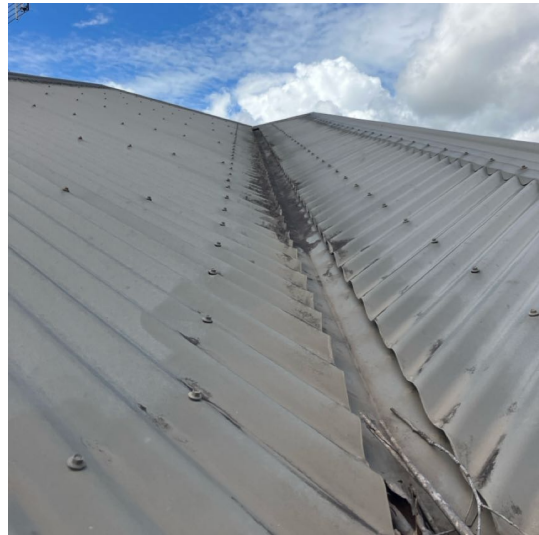
3. Flashing

- Flashing is an impervious material (usually galvanized sheet metal) that comes in a variety of shapes and sizes and is used to cover, waterproof, and direct water away from roof penetrations and from valleys and intersections between the roof covering and other materials.
- The roof flashing, where visible, appears to be in satisfactory condition.
- Some of the valley flashings have some leaf debris which should be cleared out.

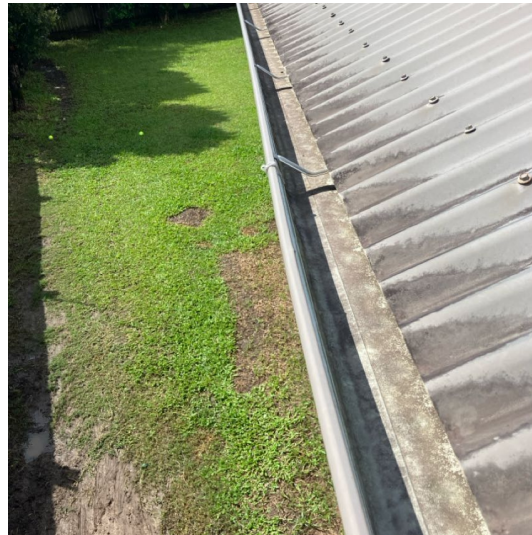
4. Roof Drainage

- No major function concerns noted at the time of inspection.
- The gutters should be regularly cleared of debris to ensure the proper flow of water from the roof.

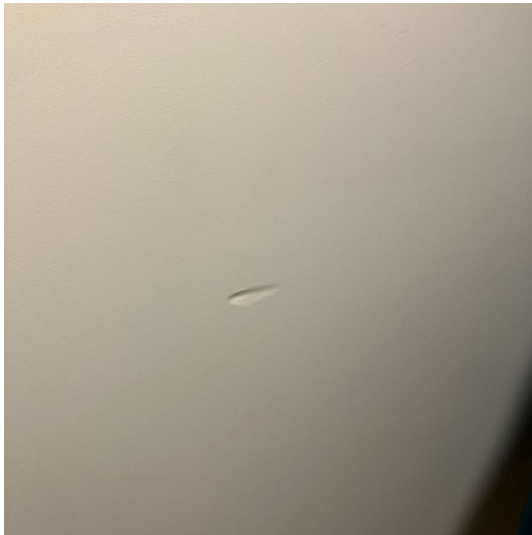
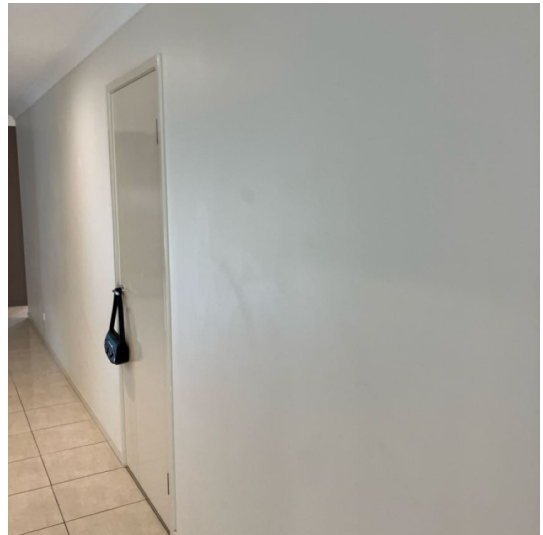
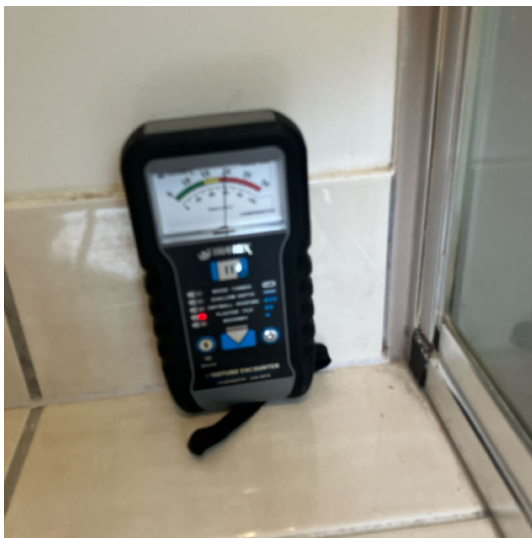
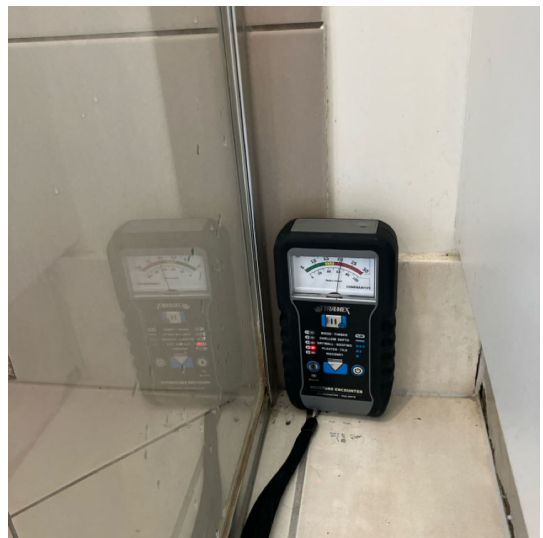
1. Wall Condition

- There are marks and imperfections to the interior walls at various locations. These can be repaired normally.
- Excessive moisture was present to the main shower walls and ensuite walls which appear to require resealing.

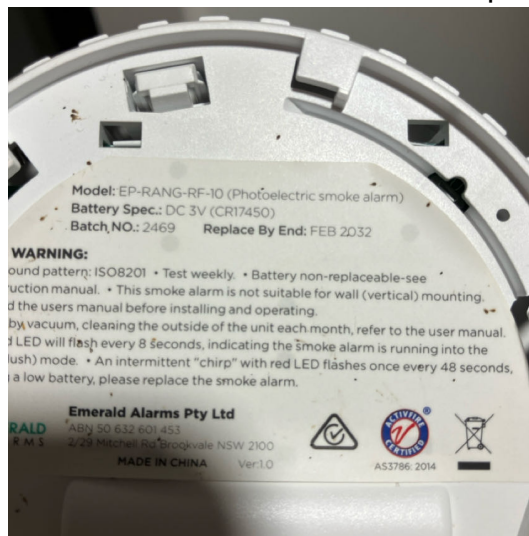
3. Smoke Alarms

- -The alarms must be-
- Hardwired to the mains power supply, if currently hardwired, Otherwise, smoke alarms can be either hardwired or powered by a non-removable 10 yr battery or a combination of both. The seller is obligated to upgrade the dwelling to the updated standard prior to the dwelling being transferred.

- The property seller must declare on a "form 24"to the buyer as part of the transfer process that the obligation has been discharged.
- There appears to be interconnected smoke alarms installed in the hallways and bedrooms of the home. The service replacement year is noted as 2032

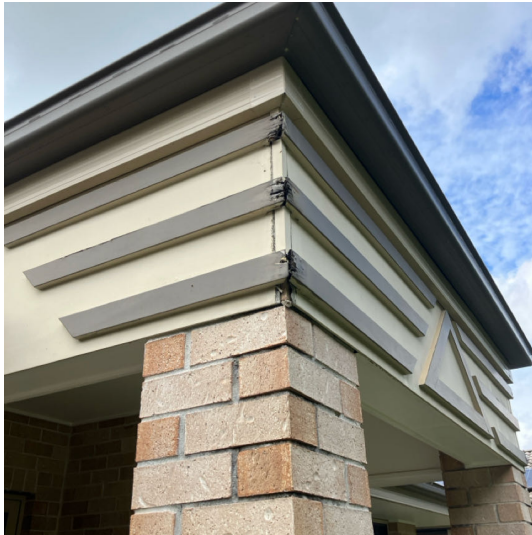
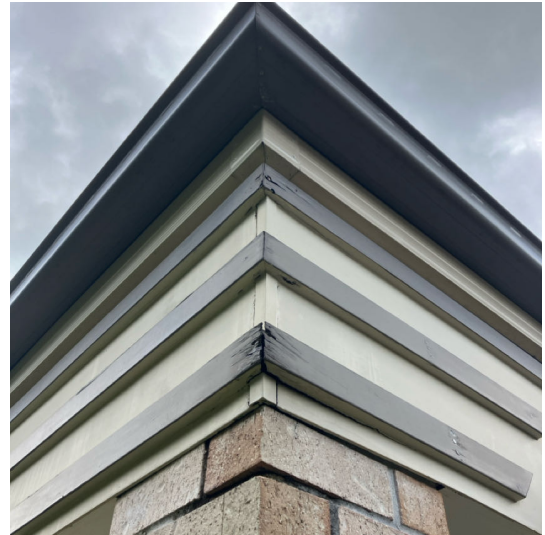
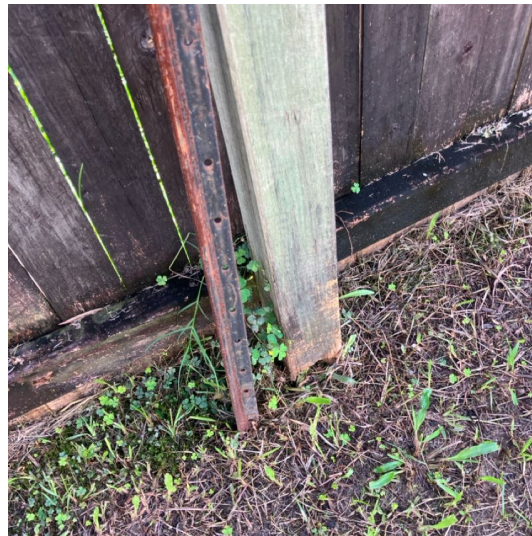
- Wood decay/fungus was detected in timber trim on front of property and the timber fence
- Timber condition is decaying.

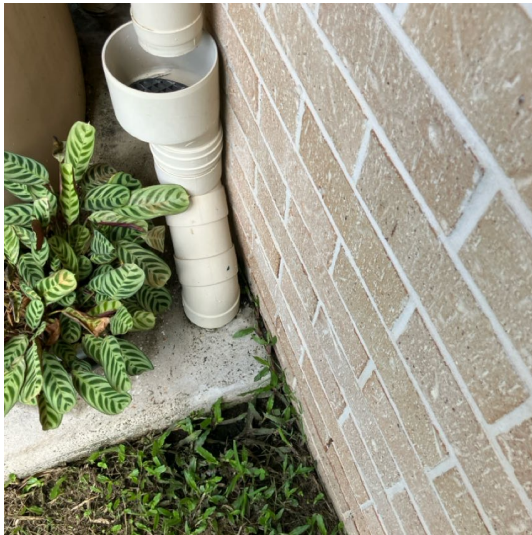
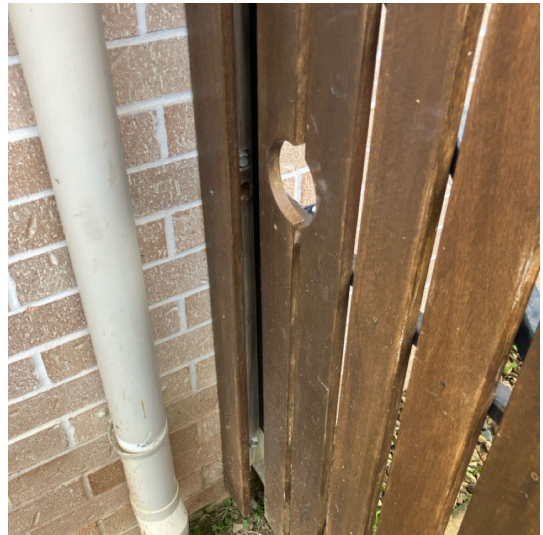
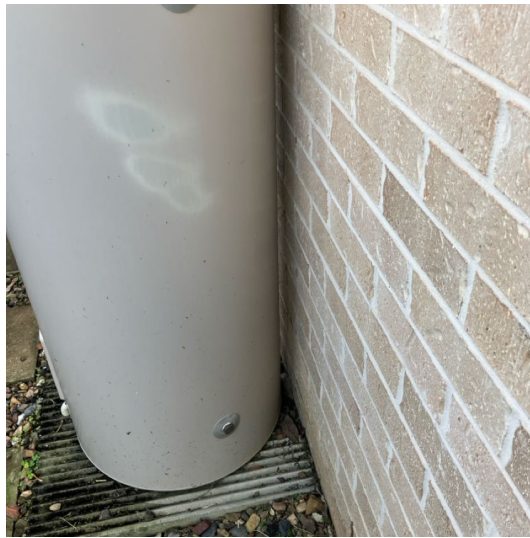
3. Bridging

The fence posts are attached to the external wall of the home and could provide concealed access for timber pest, the post should be trimmed to allow at least 75mm clearance with the finished ground surface.

The hot water system is against the exterior wall, which may allow termites to breach any barrier and gain concealed access to the property structure.

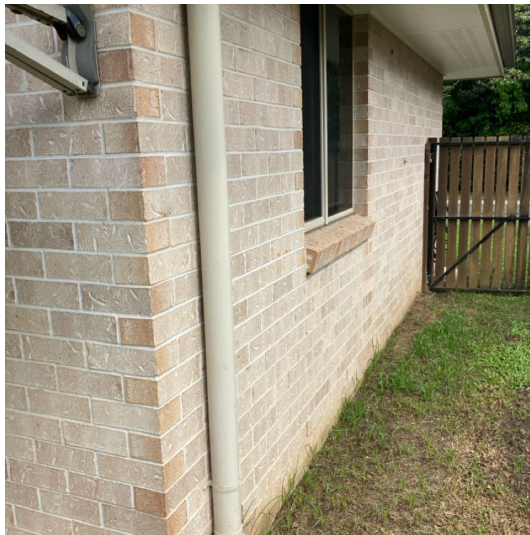
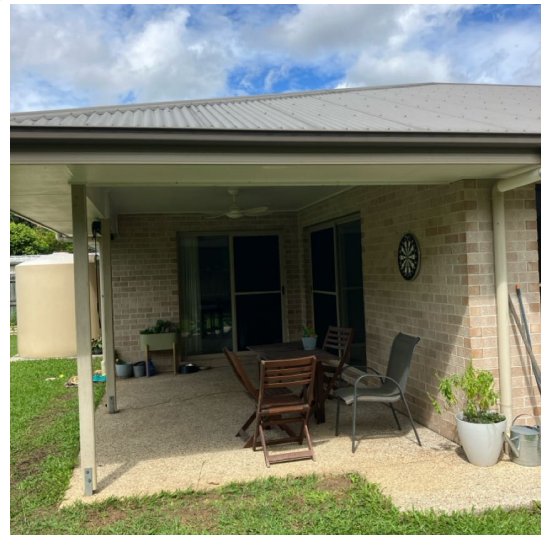
- Slab edges are covered by soil. This may allow concealed termite entry into the wall frame. Slab edges should be cleared of soil.
- Slab edges are covered by concrete. This may allow concealed termite entry into the wall frame. Slab edges should be cleared of concrete.

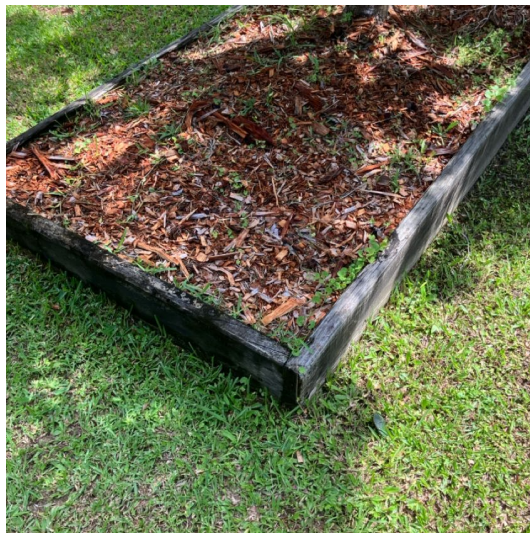
1. Pest Environment

- There is landscaping/stored timber, or old tree stumps in contact with the ground that provides possible breeding grounds for subterranean termites. These should be removed.

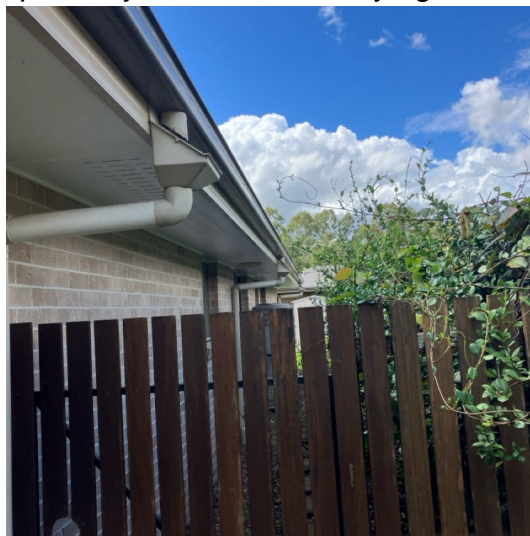
3. Vegetation Condition

- Prune or remove any plants that are in contact or proximity to home to eliminate pathways of wood destroying insects.

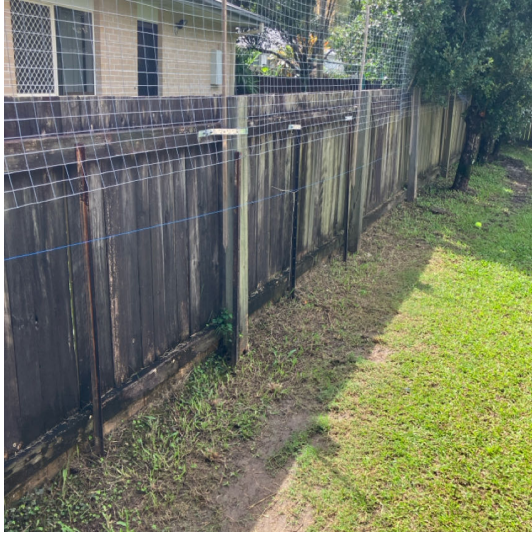
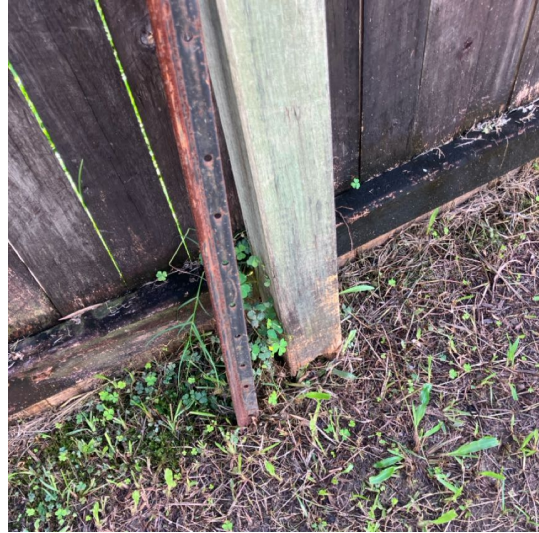
4. Fences Condition

- Wood decay observed. Recommend repairs/replacement as needed.
